Examples of Marine Accidents (Reference)

The Maritime Human Resource Institute, Japan

1. The eastern area of the Kanmon Kaikyo

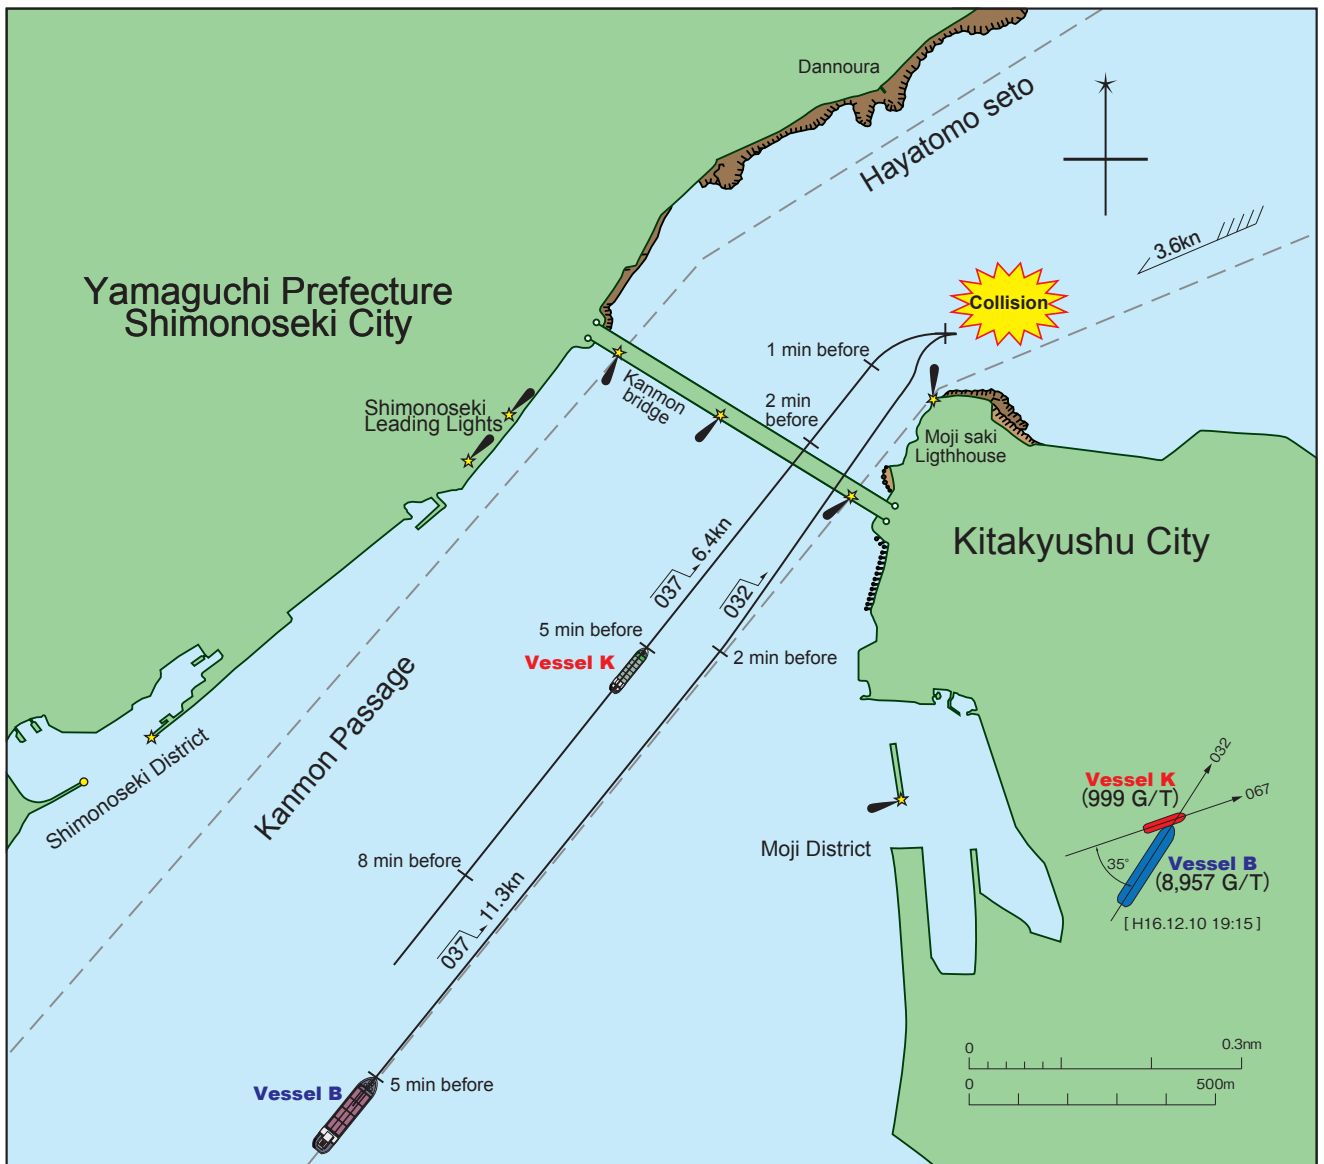
1.1 A collision occurred when a foreign-flag vessel tried to overtake an oil tanker off Moji Saki, during the westward current (Example 1)

‘**K**’, with the Captain having the con, helm in manual, was navigating eastwards but to the starboard side of the course. For her the current was strong and favourable. She had sighted ‘**B**’ getting closer from the starboard quarter, but decided ‘**B**’ would not overtake in the vicinity of Kanmon Bridge, and she continued to proceed without watching the other ship’s movements. Meanwhile ‘**B**’, similarly with the Captain having the con, manual helm engaged and proceeding eastwards, was approaching the termination of that course and, because the current was relatively weak, judged that she could overtake ‘**K**’. She based her judgment on the supposition that as ‘**K**’ should turn slowly to starboard along the course even when both vessels were rounding Moji Saki, and she could overtake her. ‘**B**’ did not make the overtaking signal by whistle. ‘**B**’ steered the course to the port side to maintain a distance from Moji Saki 2 minutes before the collision and immediately after passing the Kanmon Bridge. She then tried to steer a course to starboard, but collided with ‘**K**’ because the westward current on her bow was too severely affecting her and it prevented her from turning into it.

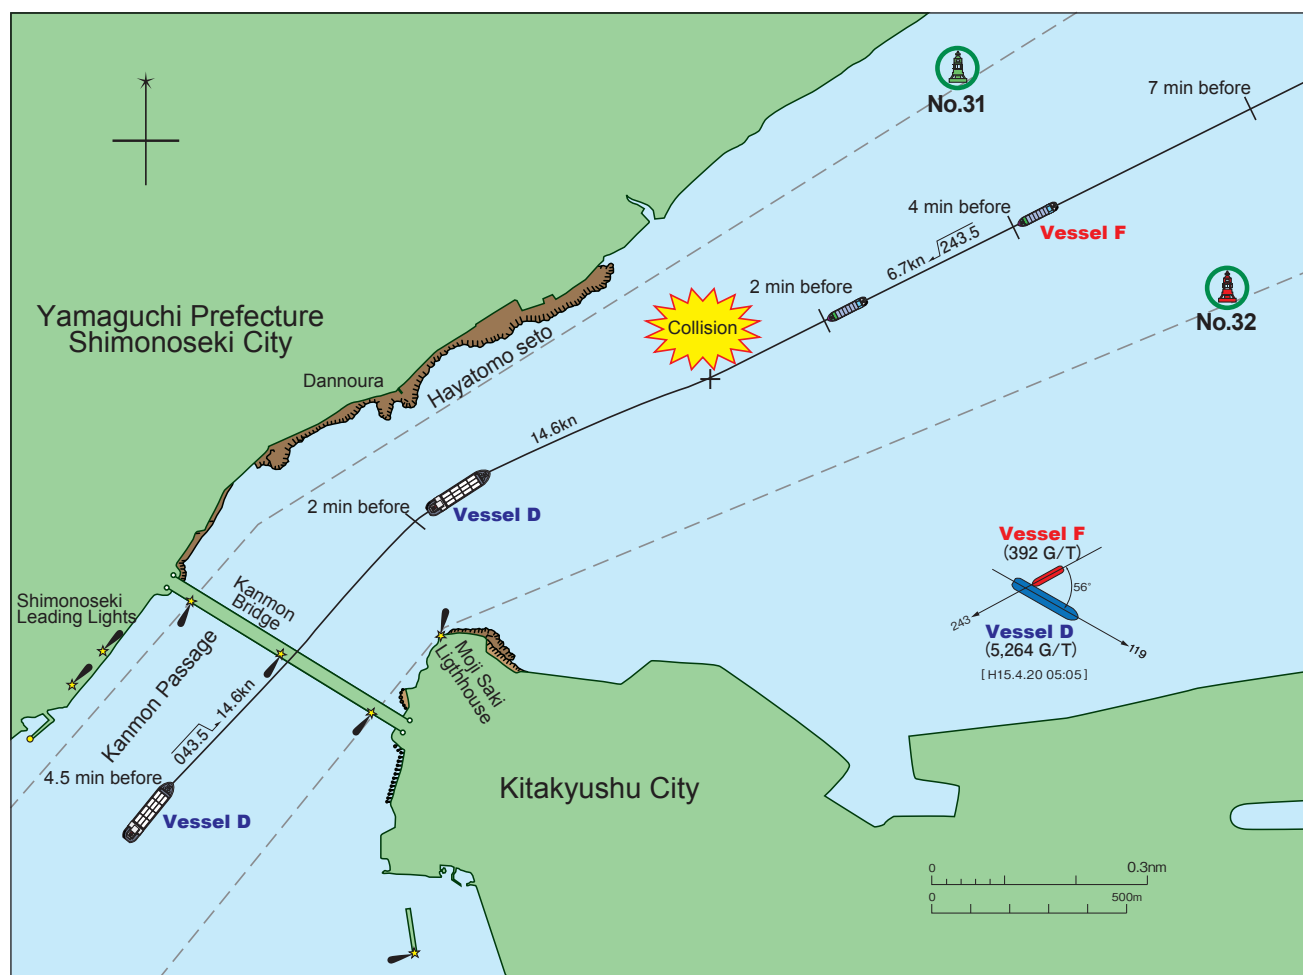
1.2 During the eastward current, at Hayatomo Seto an eastbound vessel collided with a westbound vessel, having been set off towards Dannoura. (Example 2)

The Japanese cargo ship 'F' was sailing westward under the con of the Master, in the manual steering mode, in the middle of the passage, heading towards Hayatomo Seto. The Captain, preoccupied with maintaining a distance from the north shore, did not notice the lights of 'D' ahead of her and coming down.

'D' was navigating eastward in the favourable current off Moji Saki, in the Kanmon Passage, and she was aware of 'F' 's lights, but she still collided with 'F' when she started to turn 10 degrees to starboard after being set off towards the Shimonoseki side. The cause of the collision was 'D' 's entering into the portside of the passage because of her late alteration of course to starboard.

Vessels navigating eastward in the Kanmon Passage are likely to be set off towards the Shimonoseki side regardless of the tidal current direction. Especially, vessels navigating eastward in the middle of the passage at night against the eastward current, when they are late with steering off Moji Saki and they enter the swiftest current area, they will not only be set off towards the Shimonoseki side, but it will be difficult to get rudder effect due to the favourable current which renders the ship unable to turn to starboard. Then, they can get close to a vessel navigating westward. Caution is required.

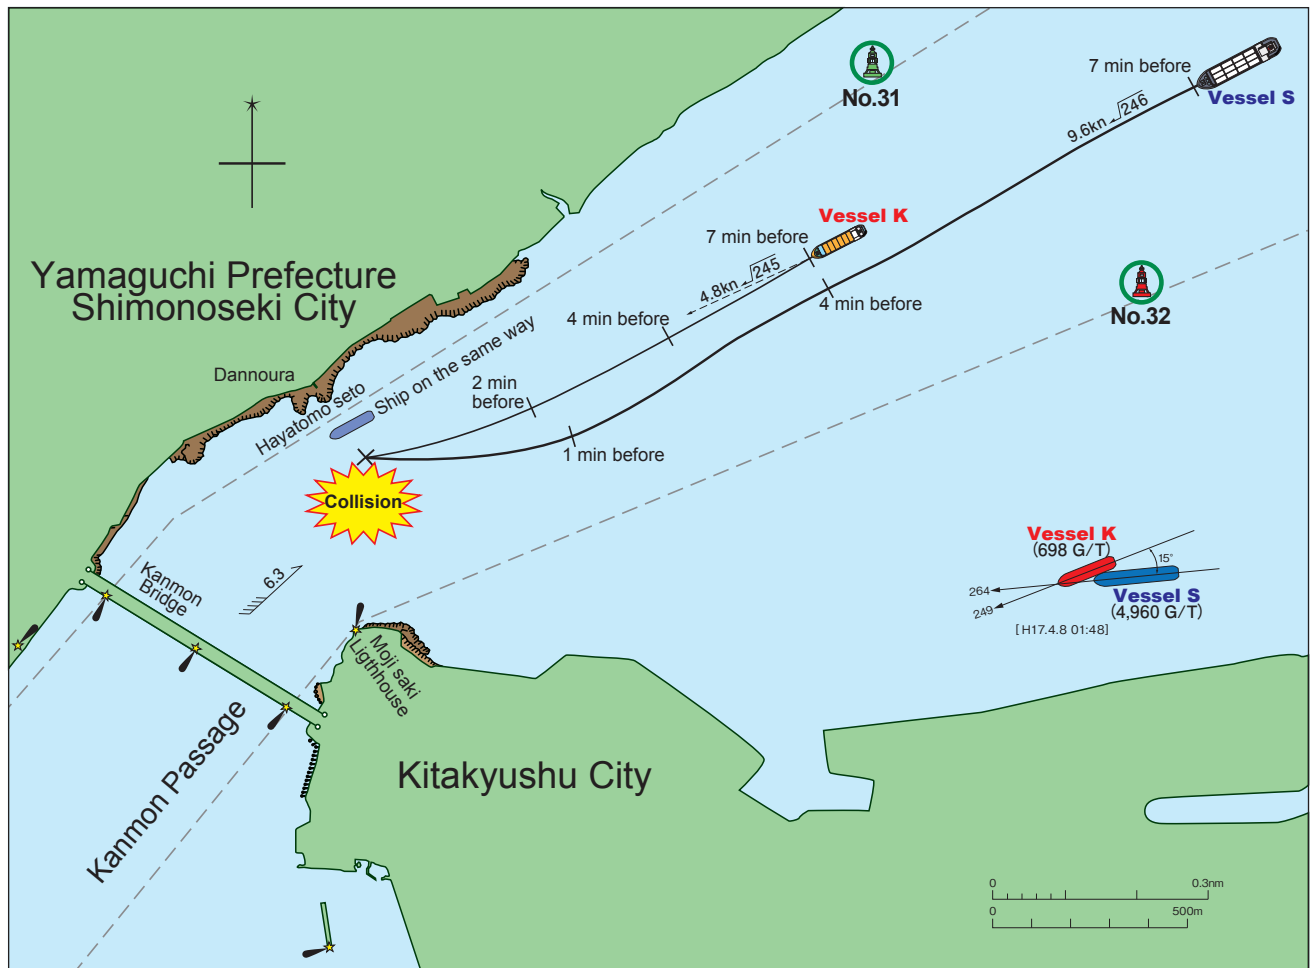
1.3 In an eastward current of 6 knots, in Hayatomo Seto, a foreign vessel collided with a Japanese oil tanker when trying to overtake her from the port side of the passage.(Example 3)

The Panamanian-flag freighter 'S' was sailing southwestward in the middle of the Kanmon Passage at Hayatomo Seto, with the intention to overtake the Japanese tanker 'K'.

Kanmon Kaikyo VTS center gave a warning to the freighter by VHF, saying 'Do not overtake the tanker 'K''. The freighter, however, did not respond to this call and continued overtaking the tanker, by proceeding to the port side of the passage. At about the same time, the freighter noticed the lights of two eastbound vessels and attempted to return slightly to the starboard side of the passage but she was set off towards Dannoura, resulting in a collision with the tanker 'K'.

Vessels in the Kanmon Passage and No.2 Kanmon Passage shall keep as near to the outer limit of the passage which lies on their starboard side as is safe and practicable. Furthermore, in the Kanmon Passage, vessels are prohibited from making risky overtaking moves; and, parallel navigating with another vessel is also prohibited. As demonstrated by this case, it is important to refrain from overtaking another vessel in Hayatomo Seto.

When sailing in Hayatomo Seto, a Captain is urged not to feel time-pressed, hurried, or required to fight the current, but to keep a sufficient distance from other vessels, especially those ahead, and to navigate with caution.

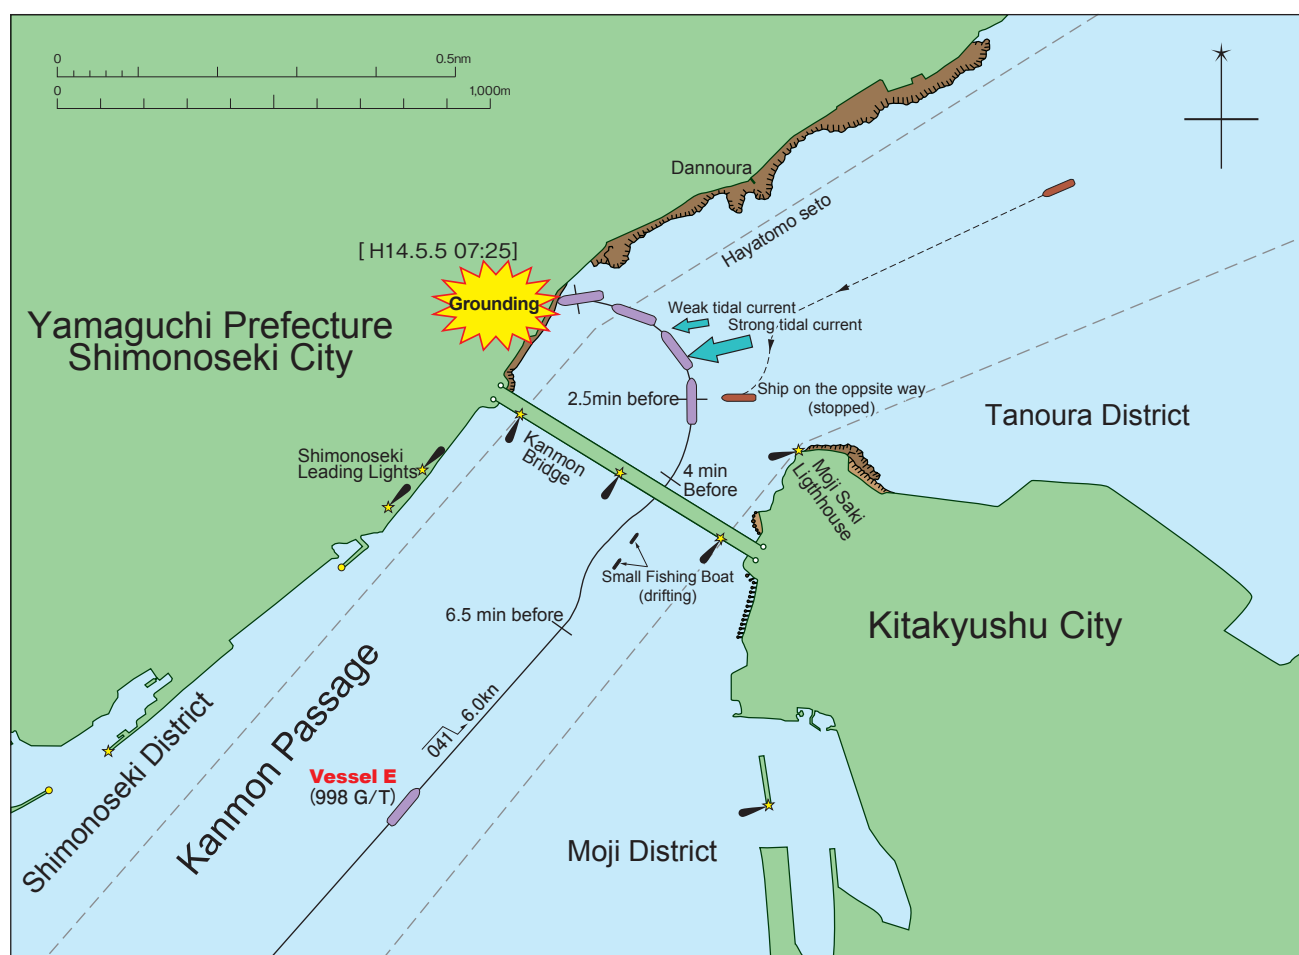
1.4 In fog and during the westward current in the Hayatomo Seto, a vessel ran aground trying to avoid a vessel coming down from ahead. (Example 4)

While navigating eastward in the Kanmon Kaikyo in restricted visibility, the oil tanker '**E**' detected 2 fishing vessels by radar west of the Kanmon Kaikyo Bridge. She moved towards the middle of the passage, avoided the fishing vessels, and when passing under Kanmon Bridge, she sighted a vessel navigating westwards in the middle of the Kanmon Passage. '**E**' took evasive action with a hard over to port in order to avoid the other vessel which was stopped off Moji Saki.

'**E**' then continued to turn round, intending to make a full round turn and reverse the course, but could not do so because of the force of the current and she ran aground.

Velocity of tidal current depends considerably on each point in the Straits. As in the above case, when a vessel proceeds at a large angle against the current direction, the bow and stern will face the differential of the tidal current velocity, and it will be quite dangerous as she may not be able to maneuver as intended.

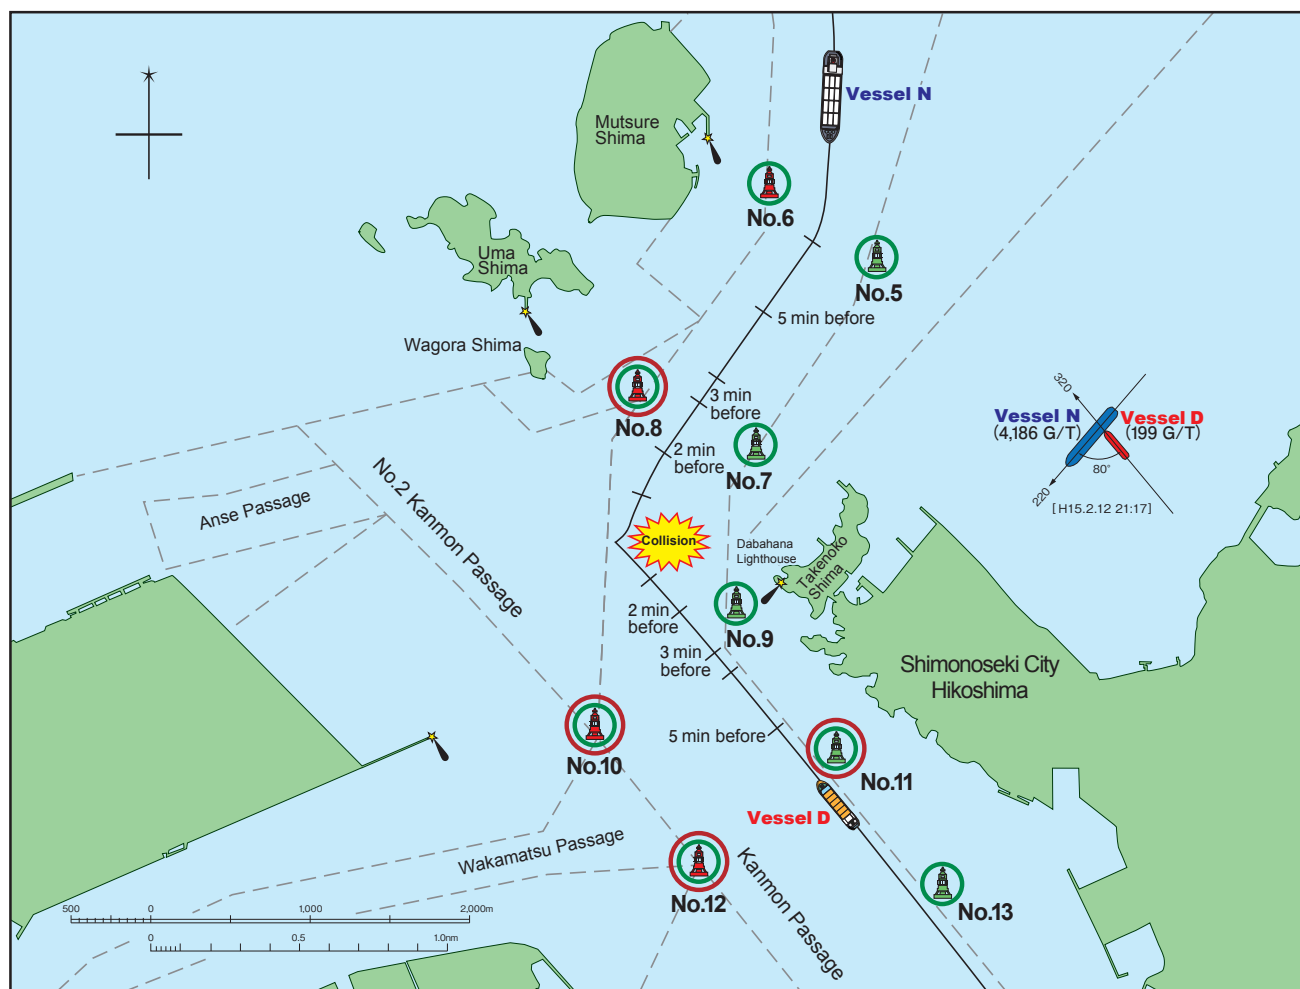
2.1 A small Japanese oil tanker which was the give-way vessel collided with a foreign-flag freighter navigating southward along the Kanmon Passage (Example 1)

While navigating northwestward in the Kanmon Passage, the Japanese oil tanker 'D' detected the Panamanian freighter 'N' by radar. However, the tanker did not monitor the movement of the freighter nor did she heed the information about the freighter 'N' that the Kanmon MARTIS gave several times to the tanker by VHF.

When the freighter 'N' made a position report to the Kanmon MARTIS by VHF, upon entering the Kanmon Passage, she received information to the effect that she might approach a small westbound vessel. She then assumed that the westbound tanker would keep out of the way of her own vessel and she continued sailing, without sounding warning signals, and they collided with each other.

In the highly dangerous environs of the Kanmon Kaikyo, a vessel that does not keep a listening watch on VHF may adversely affect many of the other vessels around her.

If you have not turned up the VHF telephone to an audible level, it is as if the telephone is inoperative. You are required to ensure that you keep a listening watch, by checking the installed location and sound volume of the VHF

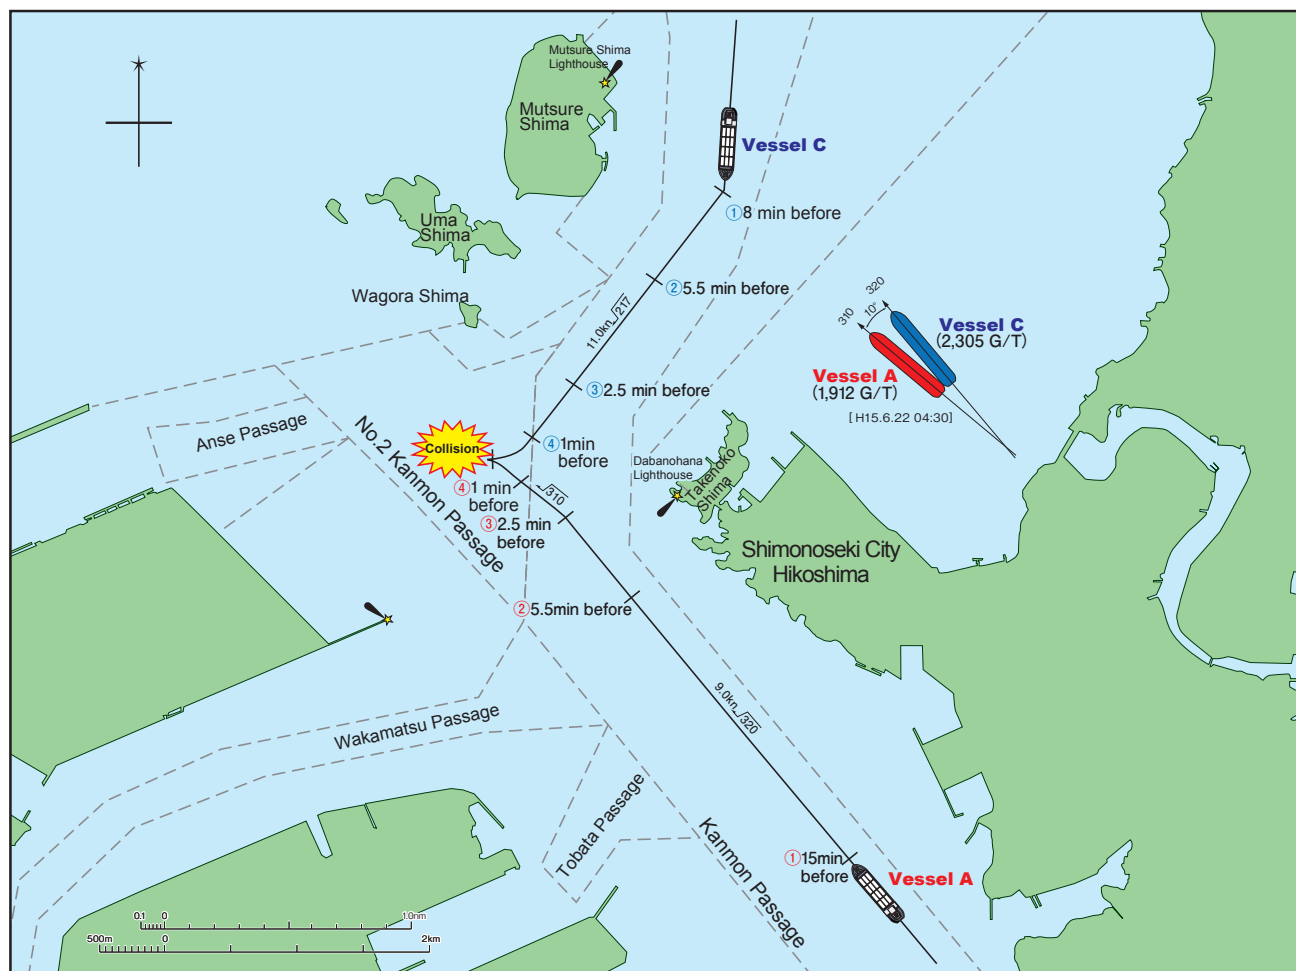
2.2 A foreign-flag freighter navigating along the passage and another foreign-flag freighter trying to get out of the passage collided (Example 2)

At night, while navigating southward after entering from the west entrance of the Kanmon Passage, 'C' detected 'A' who was navigating westward in the passage. But 'C' approached her on a collision course and continued to proceed without sounding a warning signal.

Meanwhile, 'A', navigating toward No.2 Kanmon Passage and intending to get out of the passage, sighted 'C' visibly once but did not watch her movement enough and kept moving without taking any avoiding action such that the vessels had a collision inside the Kanmon Passage.

The curved area of the passage off Daiba Hana is obstructed by Hiko Shima and Takenoko Shima. This can mean that there is insufficient time for vessels to avoid each other after a visual sighting. It is required to detect and plot by radar well in advance when navigating this tricky area. Ships must use good seamanship and navigate with caution.

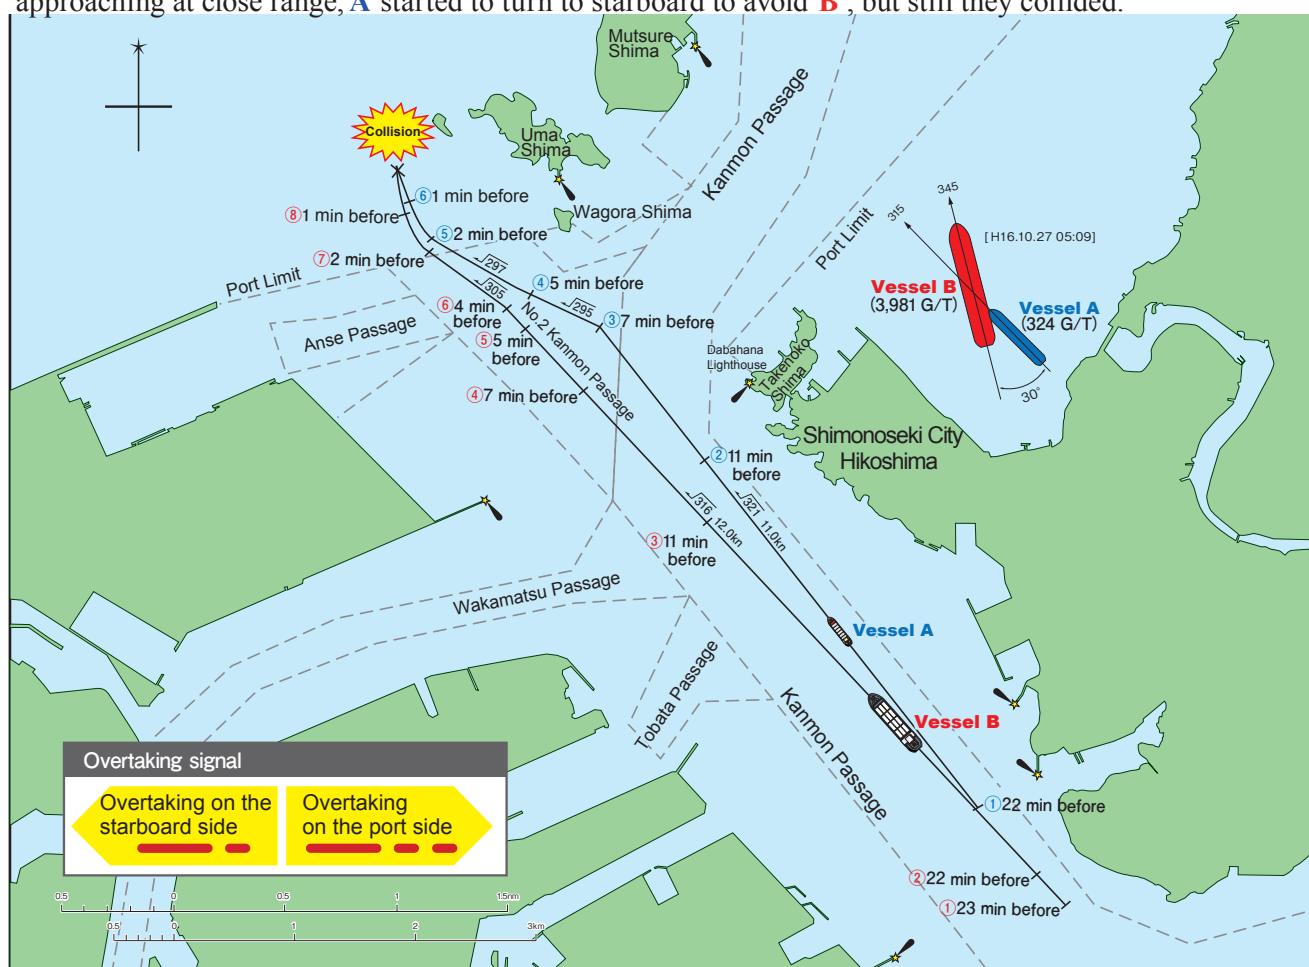
2.3 A foreign vessel collided with a live fish carrier when she overtook her in the area outside the No. 2 Kanmon Passage (Example 3)

‘A’ was navigating westward in the Kanmon Passage with automatic steering, without sounding a warning signal even though a close quarters situation with ‘B’ was developing. ‘B’ was approaching from the port quarter of ‘A’ and was navigating westward in the Kanmon Passage with manual steering.

After leaving No.2 Kanmon Passage, ‘B’ had continued her efforts to overtake ‘A’. When ‘A’ saw ‘B’ approaching at close range, ‘A’ started to turn to starboard to avoid ‘B’, but still they collided.

A vessel may overtake another vessel in the Kanmon Passage, after considering the surrounding situation and only when all conditions described below are met.

- (1) When a vessel being overtaken does not need to take any cooperation movement in order for an overtaking vessel to pass safely.
- (2) When an overtaking vessel can keep out of the way of any other vessels safely.

At any junction where courses are crossed, such as the area of south/north boarder of No. 2 Kanmon Passage, overtaking should not be done. When overtaking is allowed, an overtaking signal should be sounded and each vessel should understand the other's intentions. Vessels are to use VHF, warning signals, maneuvering signals, AIS and all other available means.

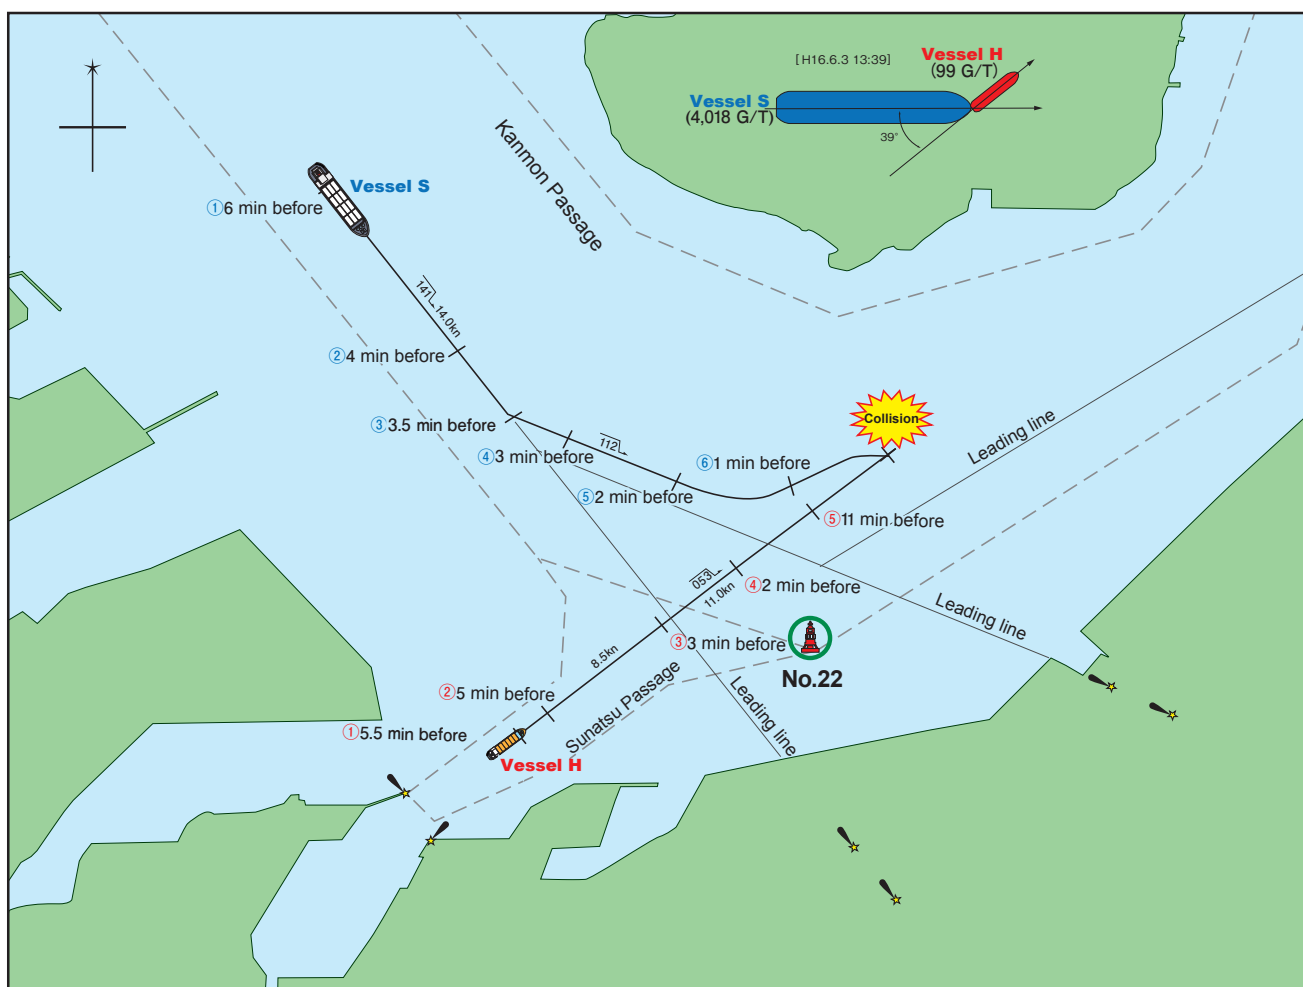
2.4 A domestic tanker leaving from Sunatsu Passage collided with a foreign-flag freighter navigating southeastward along the Kanmon Passage (Example 4)

The tanker 'H' which was engaged in domestic trade for the carriage of fuel oil, and while leaving Sunatsu Passage, was likely to encounter the Panamanian freighter 'S' which was navigating along the Kanmon Passage. After leaving Sunatsu Passage, 'H' entered the Kanmon Passage.

On the other hand, the freighter 'S', navigating eastward in the Kanmon Passage, sighted 'H' entering the Kanmon Passage from Sunatsu Passage and proceeded whilst watching her movements. Although the tanker didn't show any signs of keeping out of her way, the freighter continued navigating without sounding warning signals, and the two vessels collided.

In Kanmon Port, in the event of a risk of encounter between a vessel navigating along the Kanmon Passage and another one navigating along another passage, any vessel from another passage shall keep out of any vessel navigating along the Kanmon Passage.

The vessel intending to enter the Kanmon Passage from another passage should do so after ensuring that she is keeping clear of other vessels navigating along the Kanmon Passage by, for example, slackening her speed in ample time.
